GREAT NEAPOLITAN EARTHQUAKE OF 1857.

OBSERVATIONAL SEISMOLOGY

TO INVESTIGATE THE CIRCUMSTANCES OF THE GREAT
EARTHQUAKE OF DECEMBER 1857.

ROBERT MALLET, C.E., F.R.S., F.G.S., M.R.I.A.,
&c., &c.

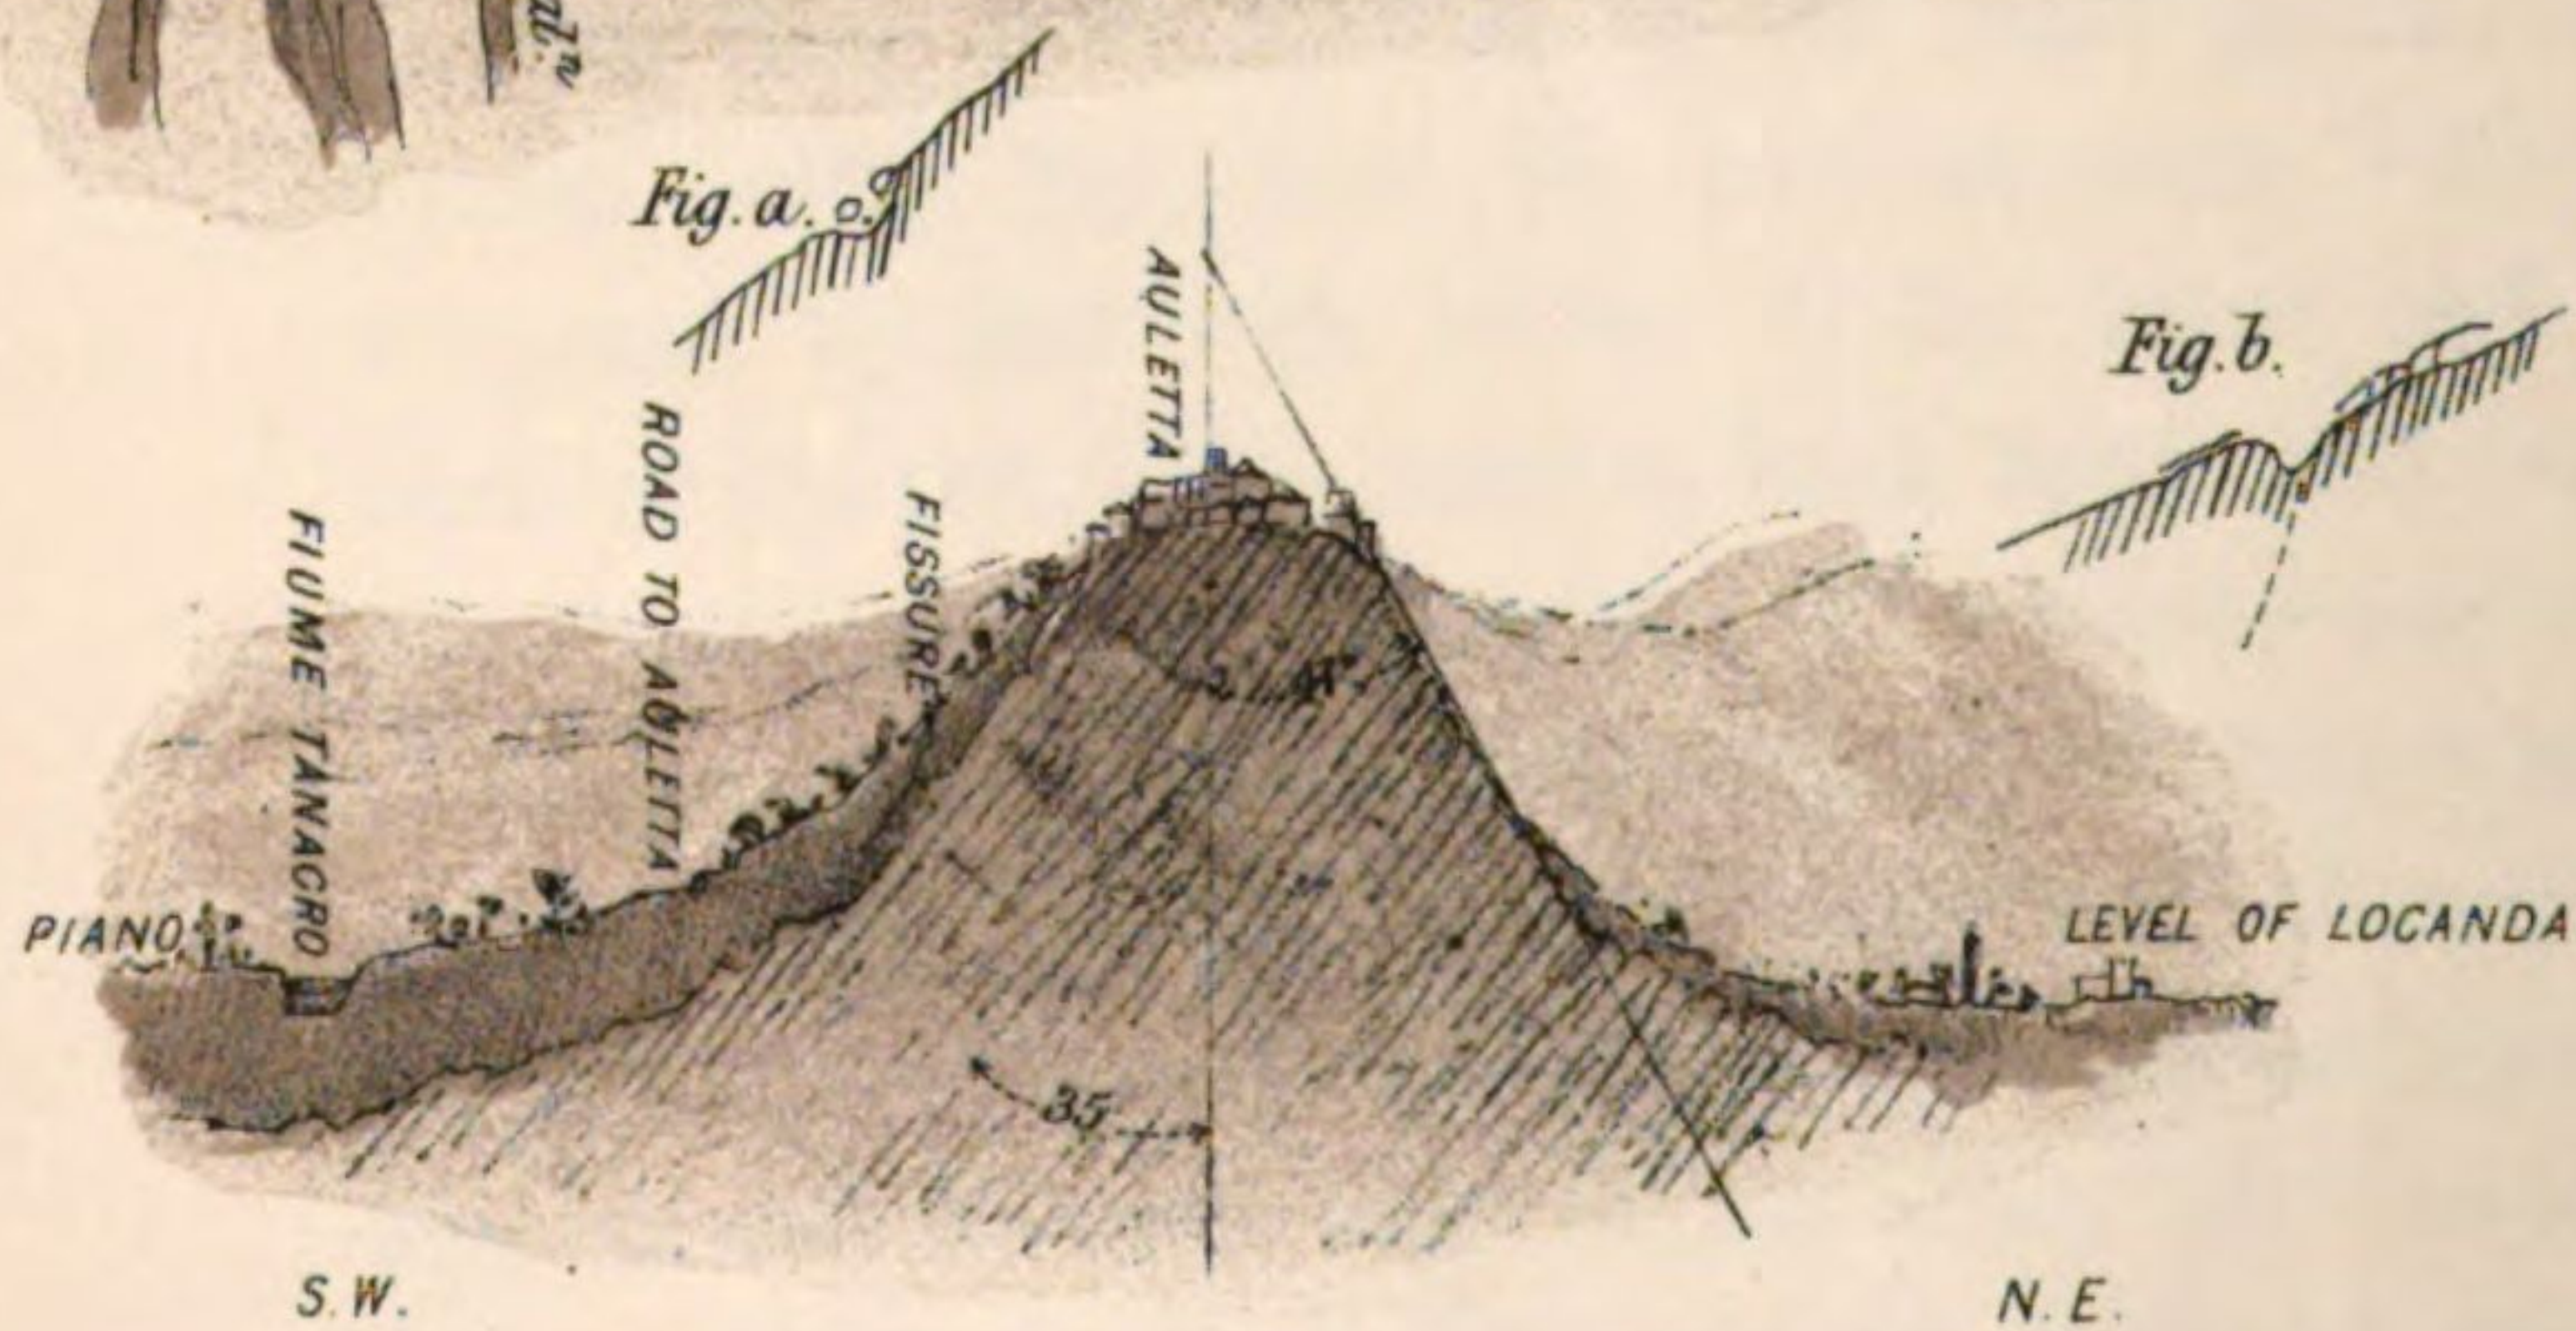
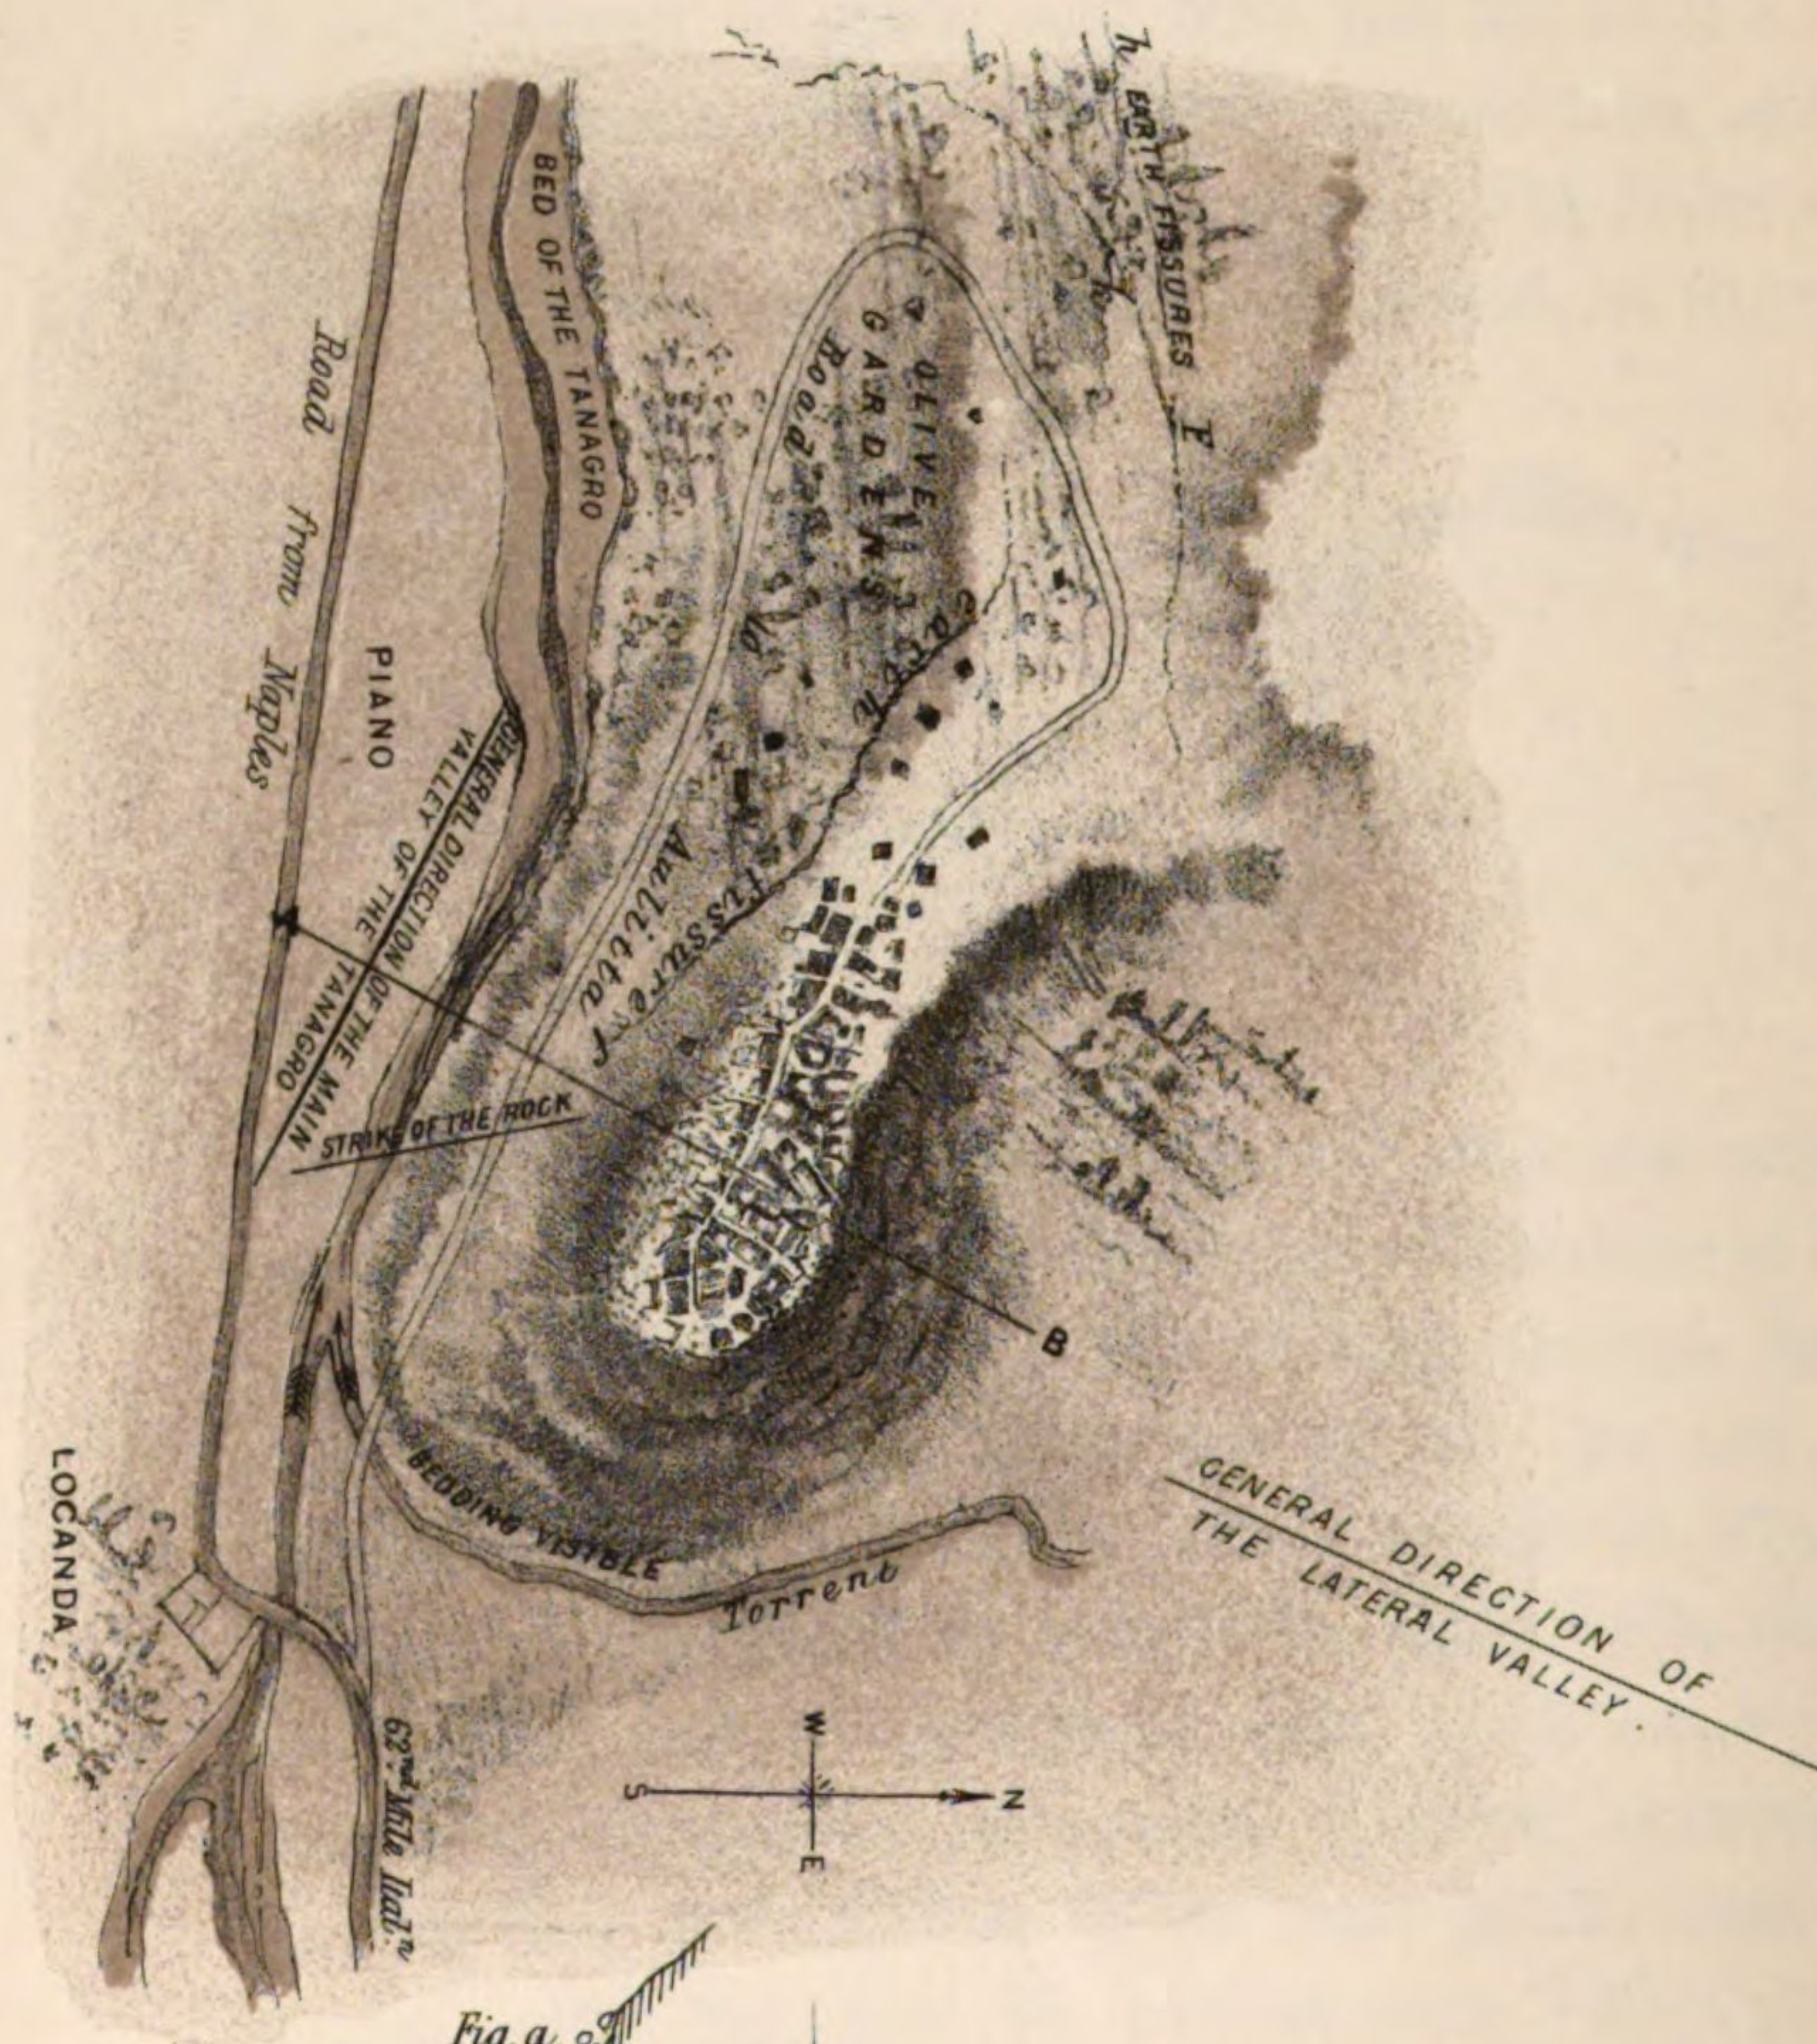
Dia^m Pl. 132.

AULETTA, SHOWING THE DIRECTIONS OF THE LANDSLIP,
AND LONG FISSURES IN THE SOIL.

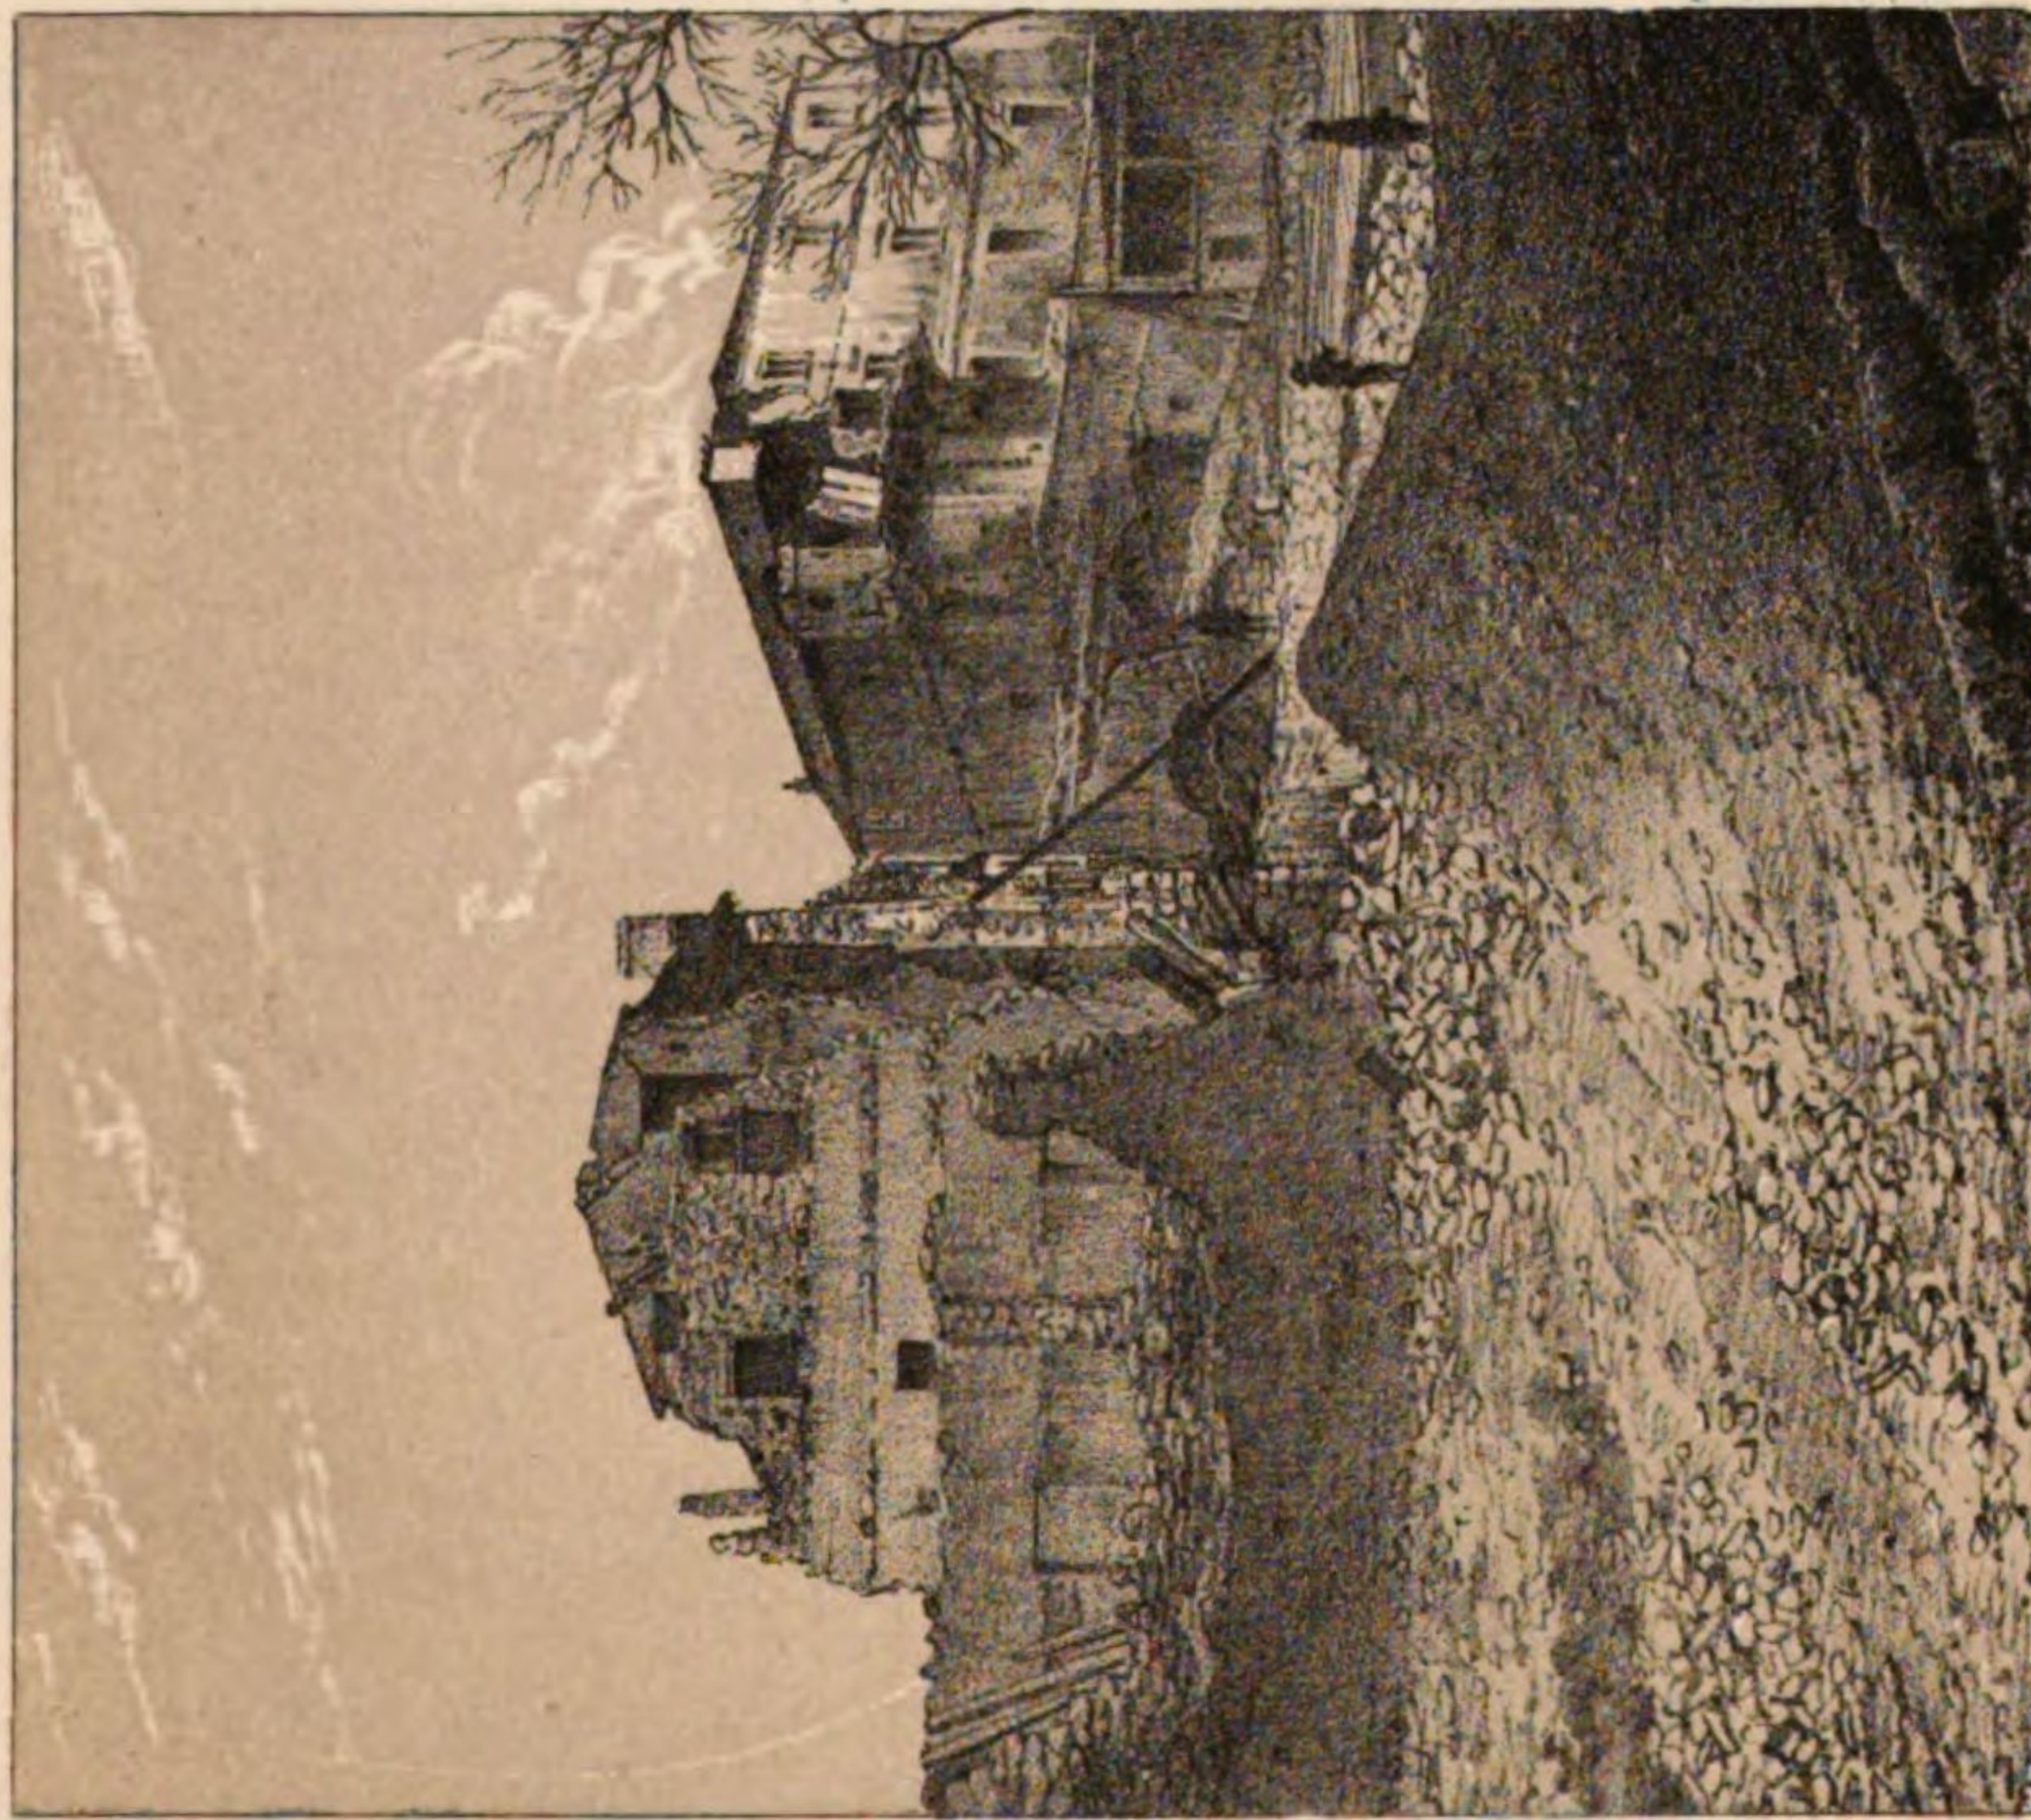
Photo. Pl. 136.

At the lower part of the town, and upon the slope towards the N. W. leading to it, the fractures all indicate a very steep emergence from the eastward—upwards of 45° ; but upon the summit, the buildings show a lower apparent angle of emergence, and *greater dislocation*. This obviously arises from the fact that, as the wave-path hereabouts was in some direction from E. to W., and therefore diagonally transverse, to the narrow or thin direction of the spur, upon which the town stands; the mass of *the spur itself vibrated*

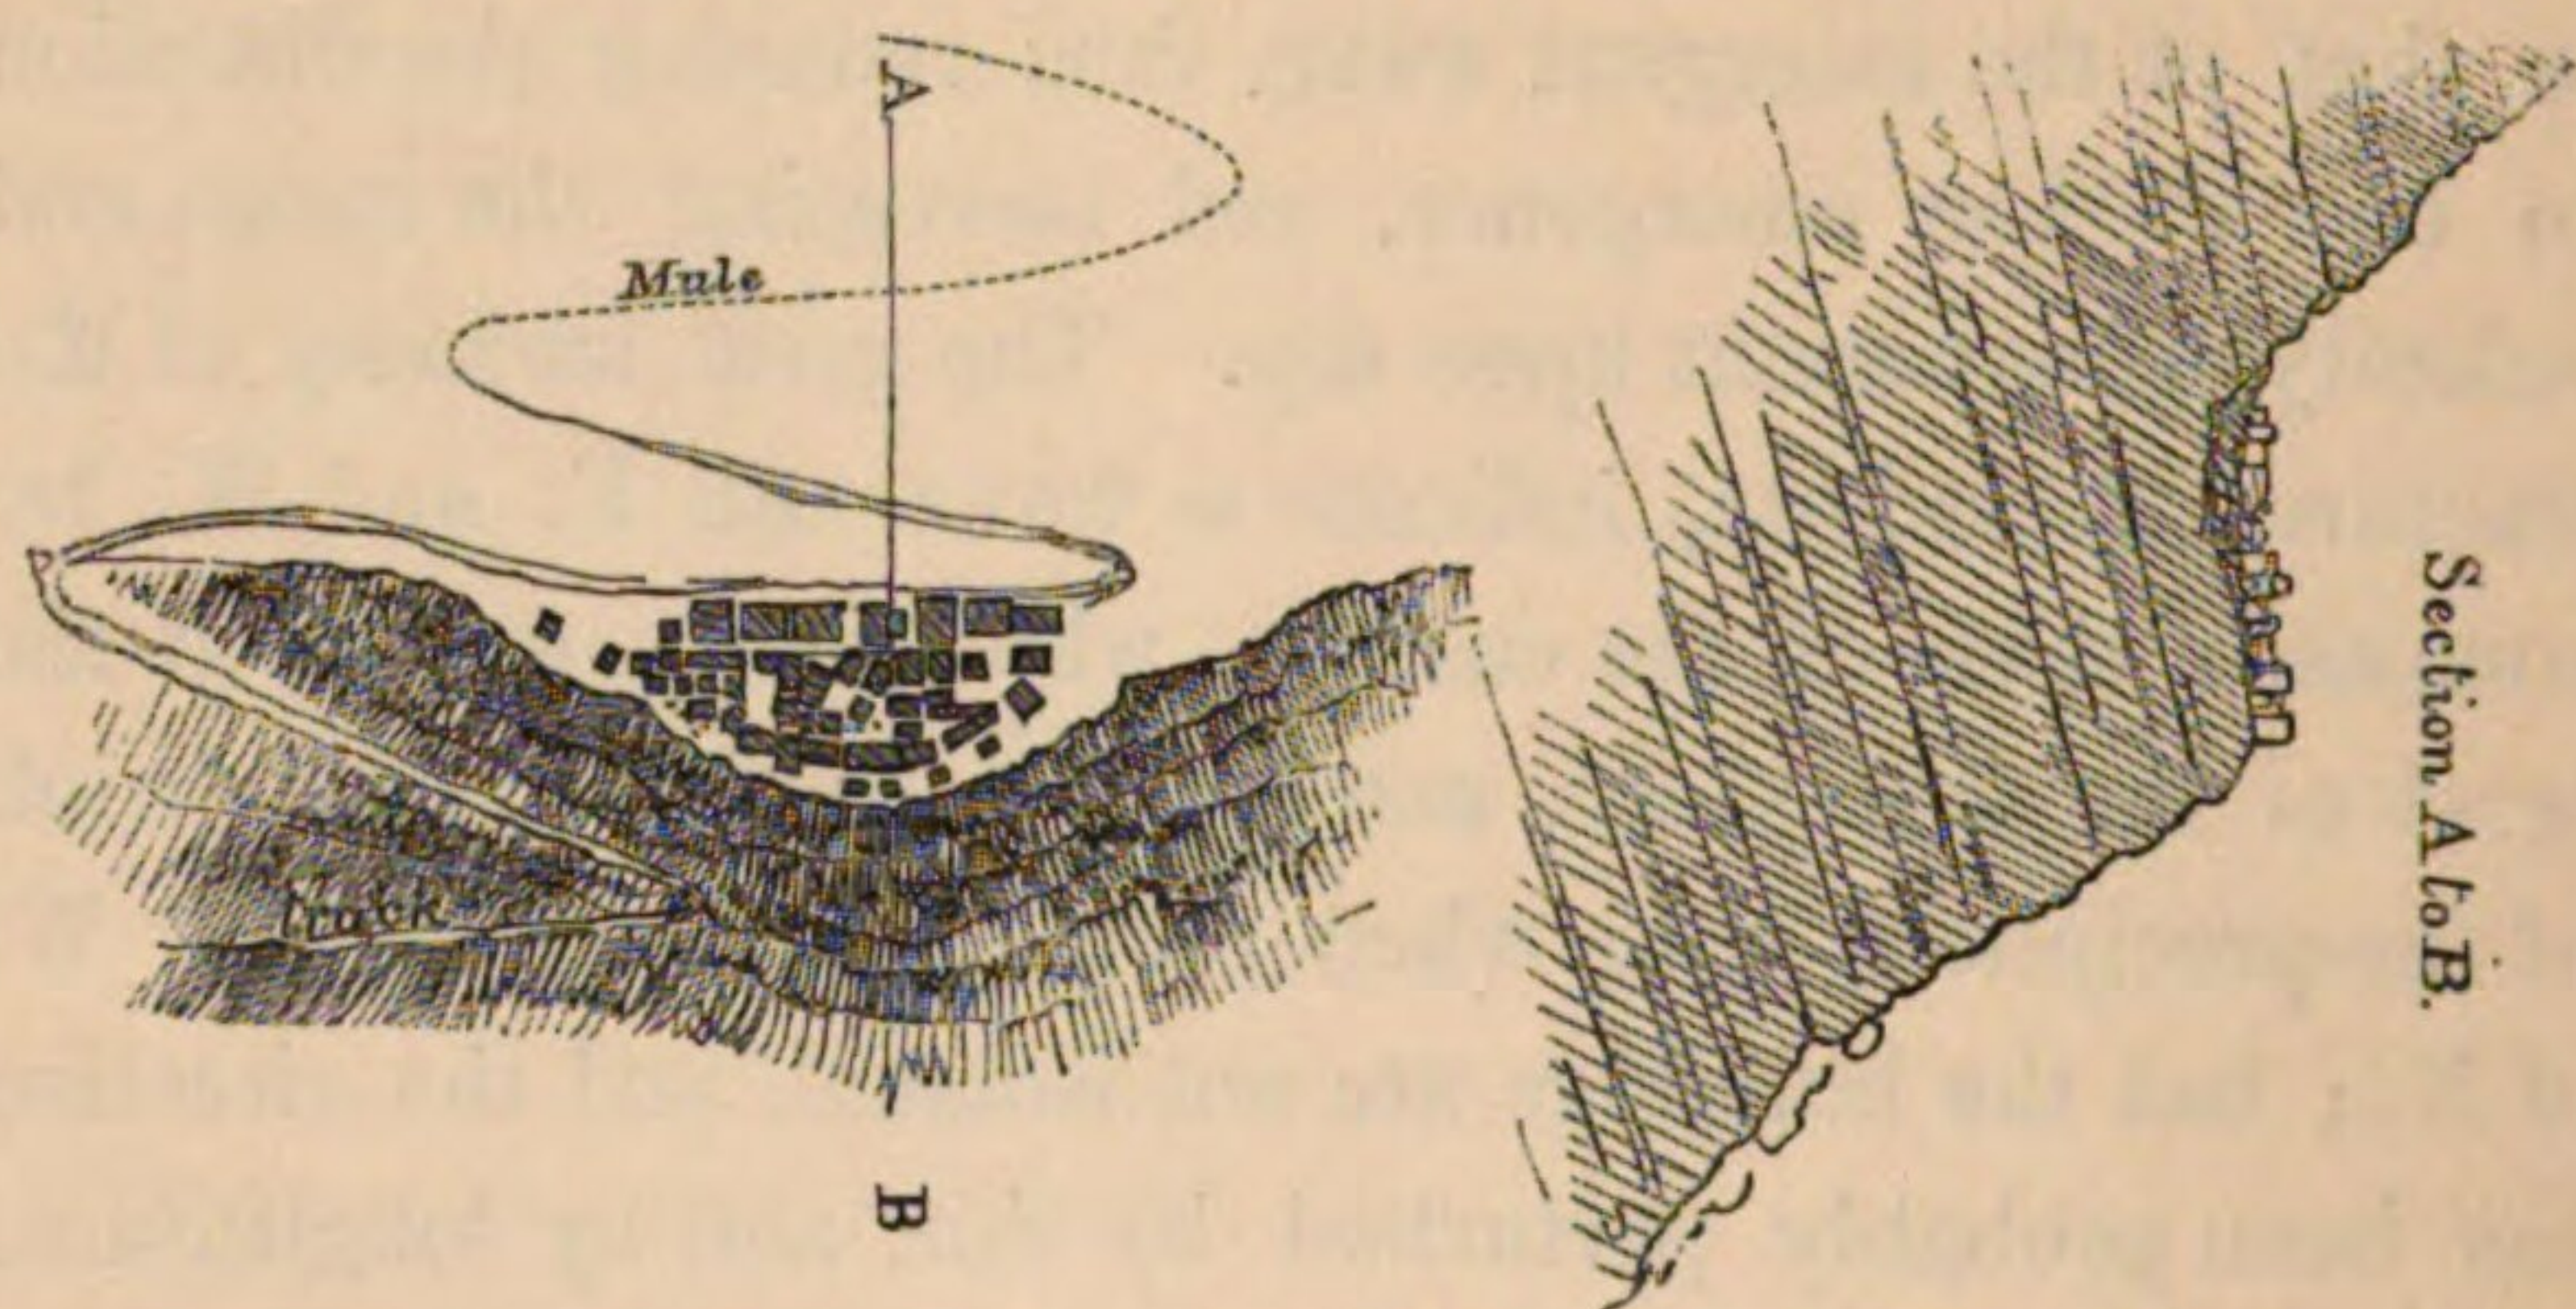
Fig. 137.

The effects, of the form, elevation above its base, substance, and direction with respect to wave-path, of the collines or spurs, upon which so many of these towns are perched, in modifying the results of the shock upon them, are strikingly seen here, as well as at Castelluccio, which we have passed, and at the little village of Petina, which, from a point between this and Pertosa, I can descry with the telescope, perched high up, upon the south scarp of Monte Alburno, at least a thousand feet above me. It stands upon a level sort of short, stumpy, buttressed spur, jutting out from the steep mountain slope, which in form is like a piece of artificial earthwork, the little town standing upon the level platform on top, with a steep scarp in front of it, the mountain rising abruptly behind, and the scarp sloping in and getting lost in the mountain sides to the E. and W. of the town. The terrace upon which it stands, however, is not earth, but solid limestone—a projection, of the great horizontal strike of the beds, of the great scarp of Alburno, as

in Fig. 137, which dip pretty sharply to the south. I find upon inquiry here that Petina, which is just five

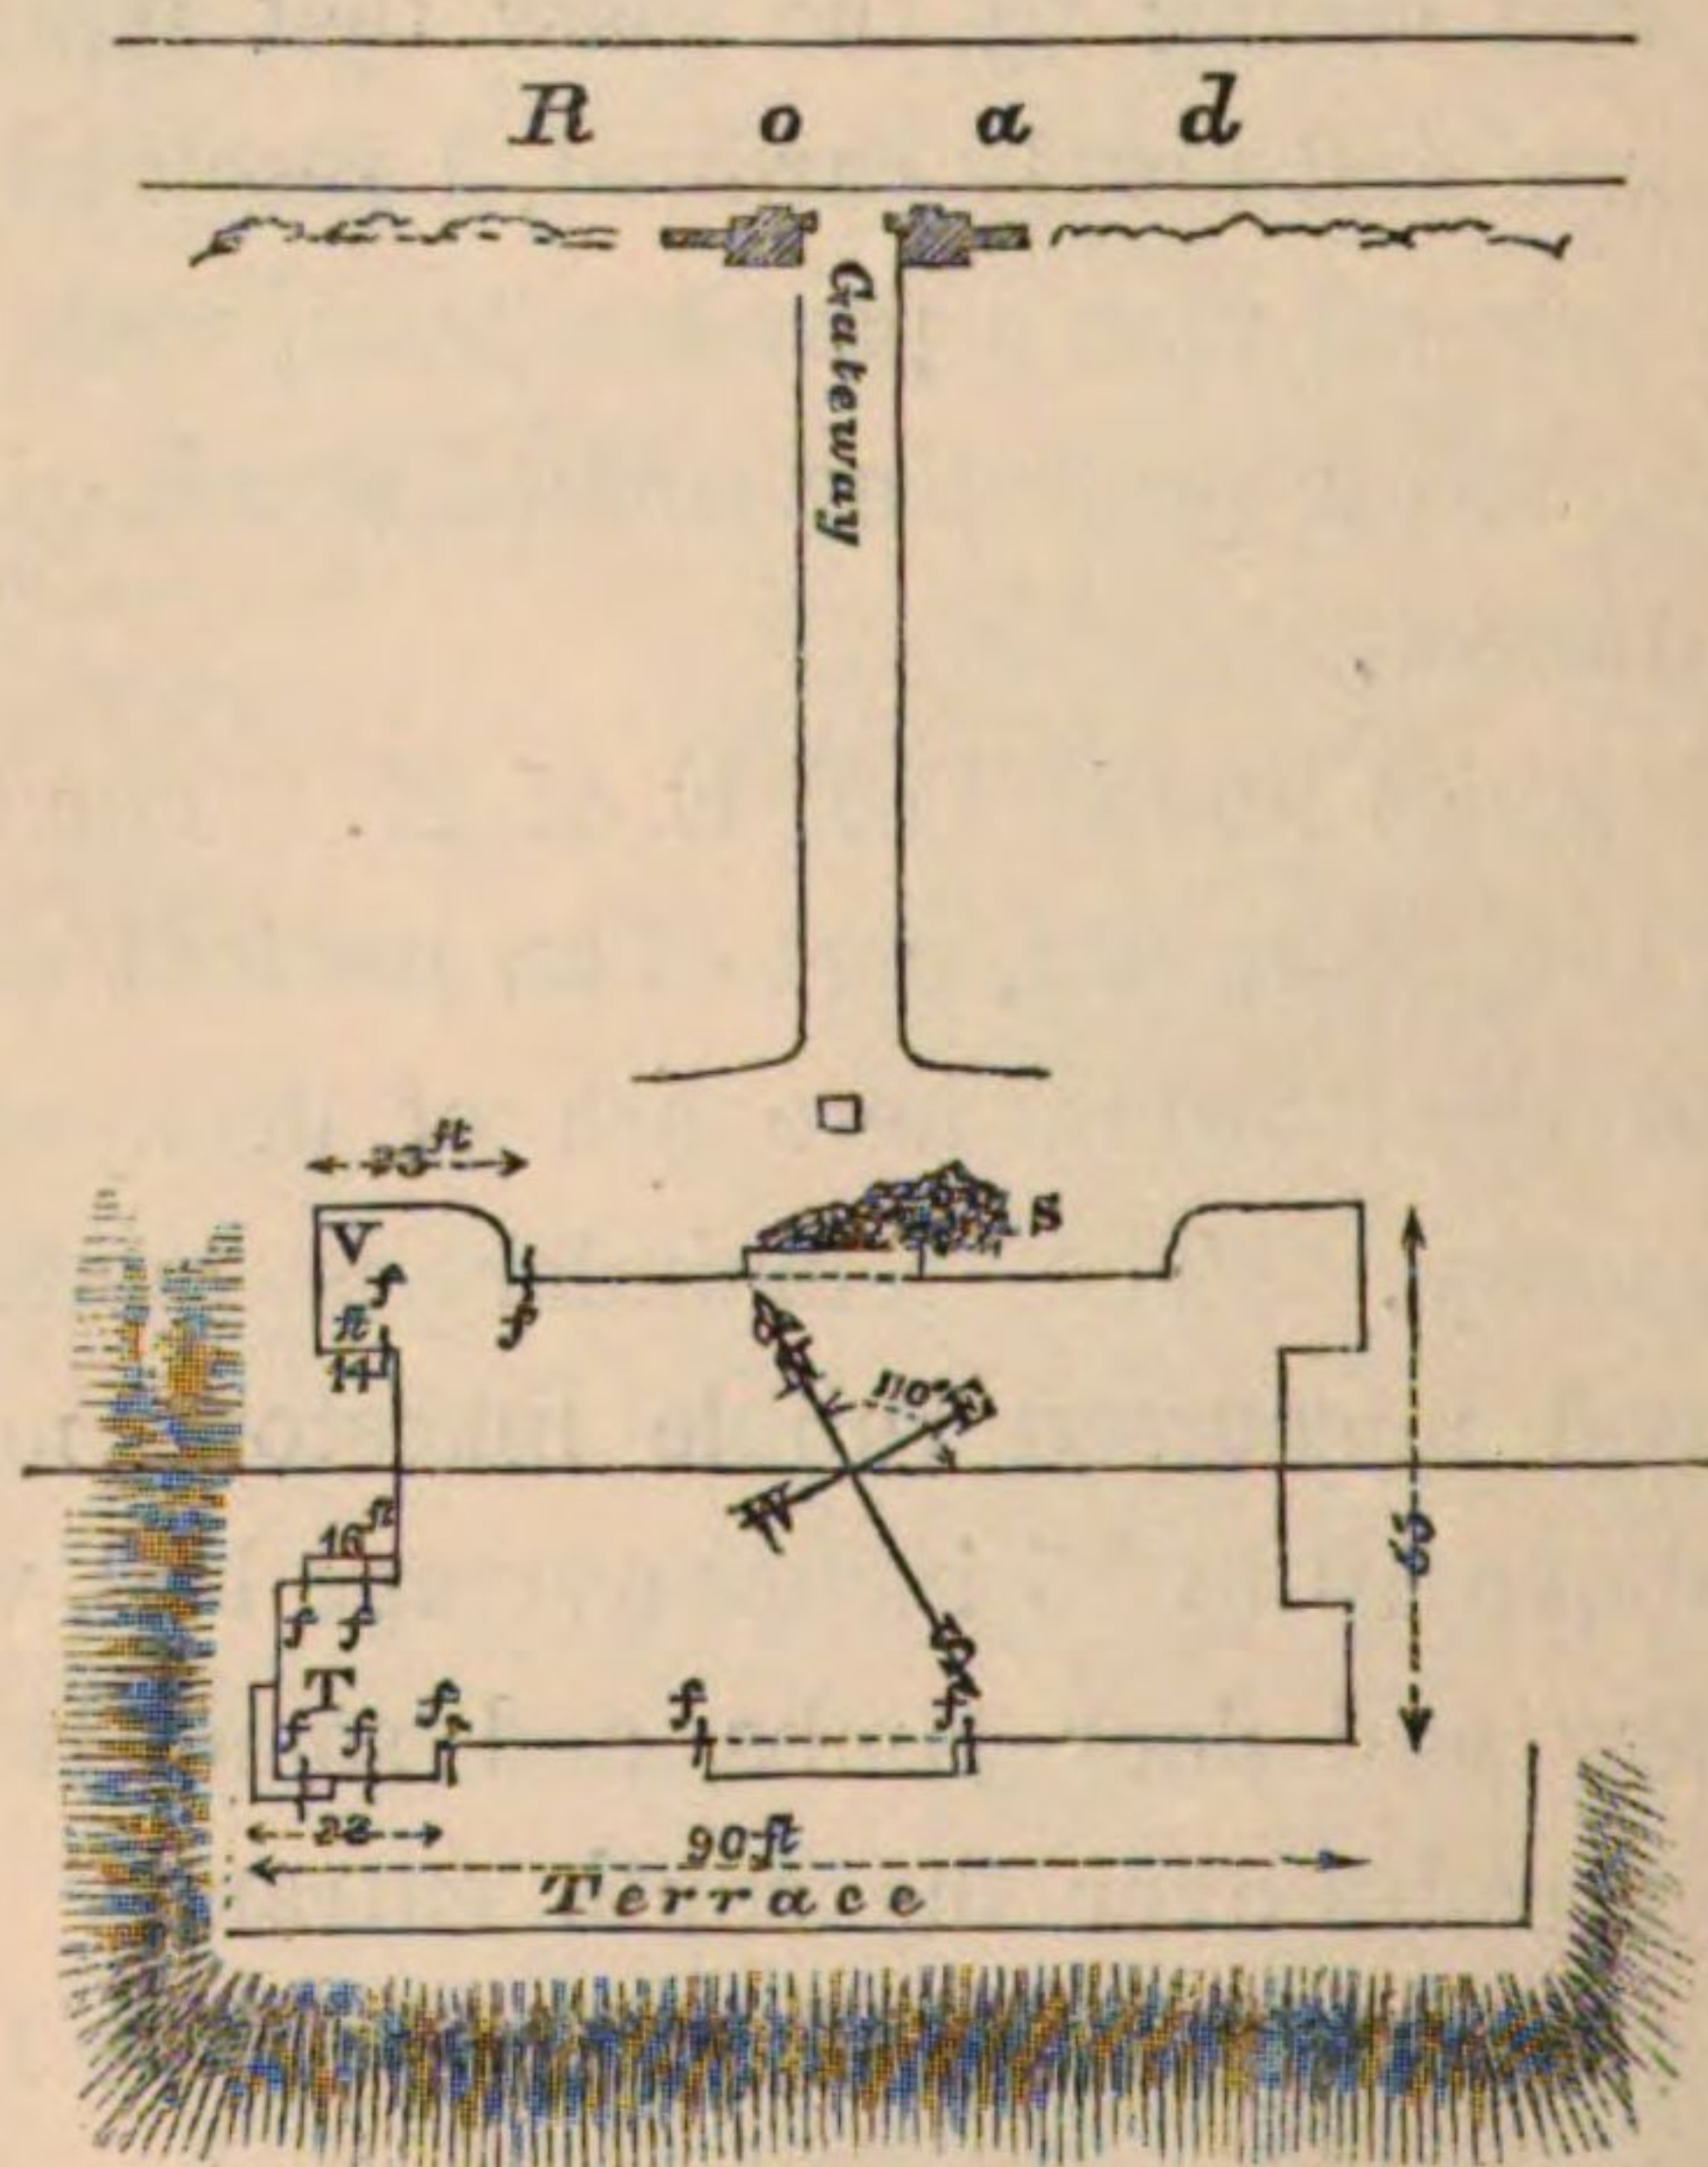
Fig. 139.

The only fissures are those marked *ff*, &c., in the west end, all in the ancient towers, and two fractures in the slender brickwork of the southern arcades. The towers have been thrown westward, off from the body of the building, and the fissures at the reënterant quoins are $2\frac{1}{2}$ inches open at top, and run nearly from top to bottom of the walls, which are about 32 feet in height to the eaves, and the whole of the west end is out of plumb. The fissures in the south front are seen in Photog. No. 137. Their direction has been determined and limited at the quoin, by the form of the buttress built into it, for nearly

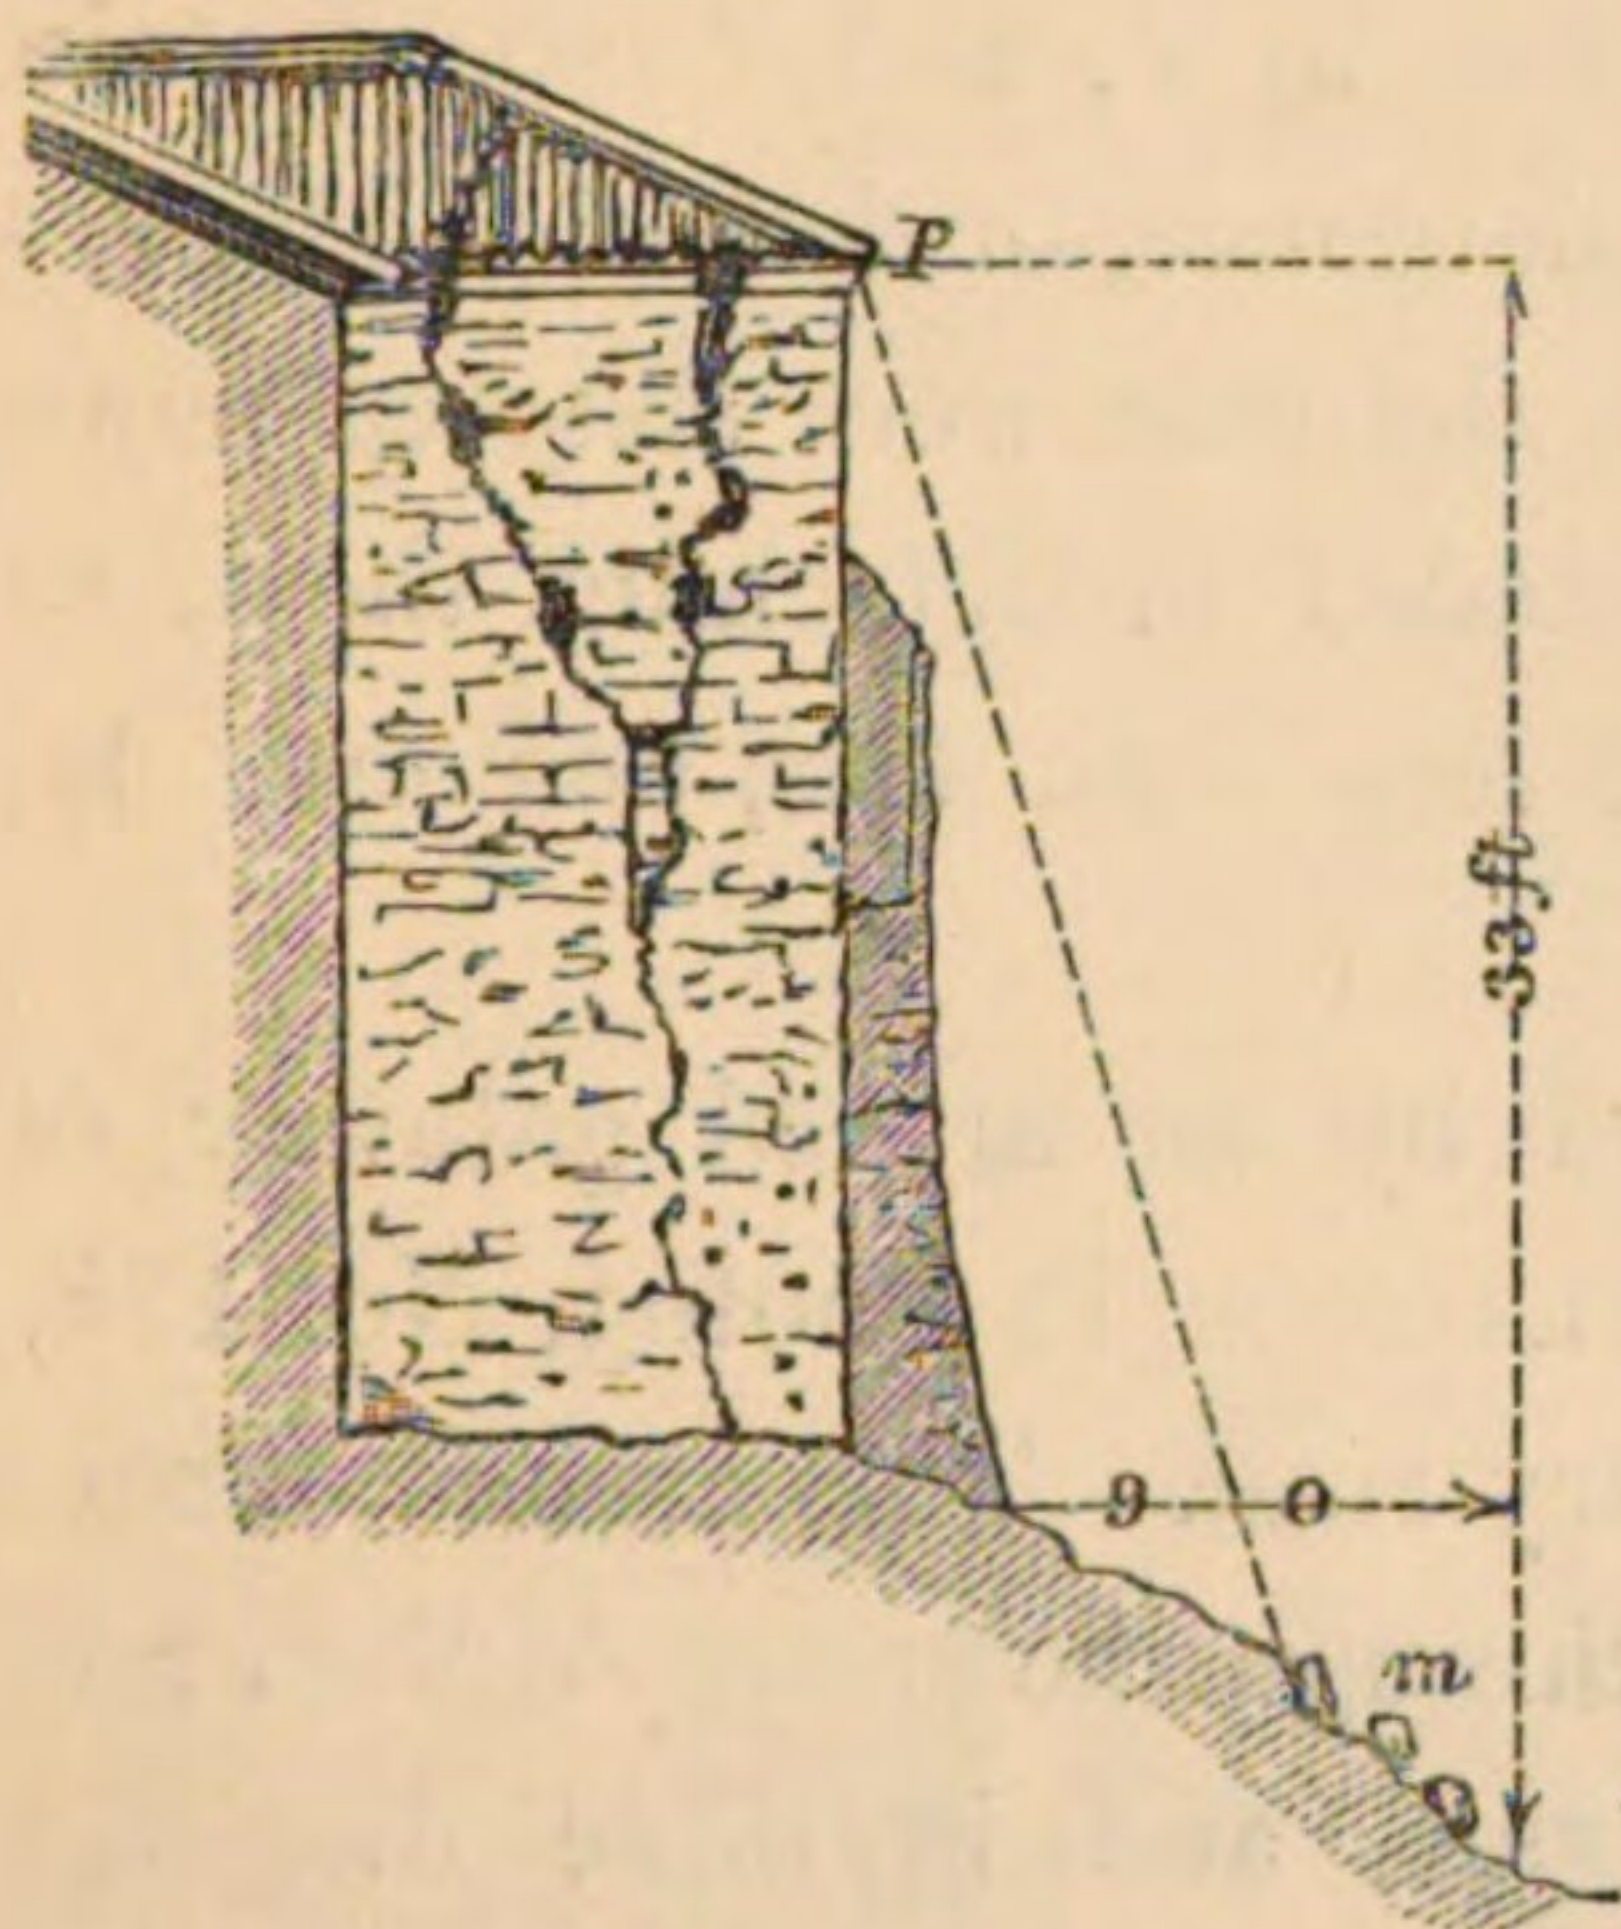
Fig. 140.

The fissures at the internal flanks of the tower, that, T, (ground plan, Fig. 139), looking south, and that, V, looking north, are pretty exactly sketched in Figs. 140 and 141.
